NAVAL WEAPONS STATION CHARLESTON FLEET MOORINGS UNDERWATER INSPECTION REPORT

JUNE 1985

OCEAN ENGINEERING
AND CONSTRUCTION PROJECT OFFICE
CHESAPEAKE DIVISION
NAVAL FACILITIES ENGINEERING
COMMAND
WASHINGTON, D.C. 20374

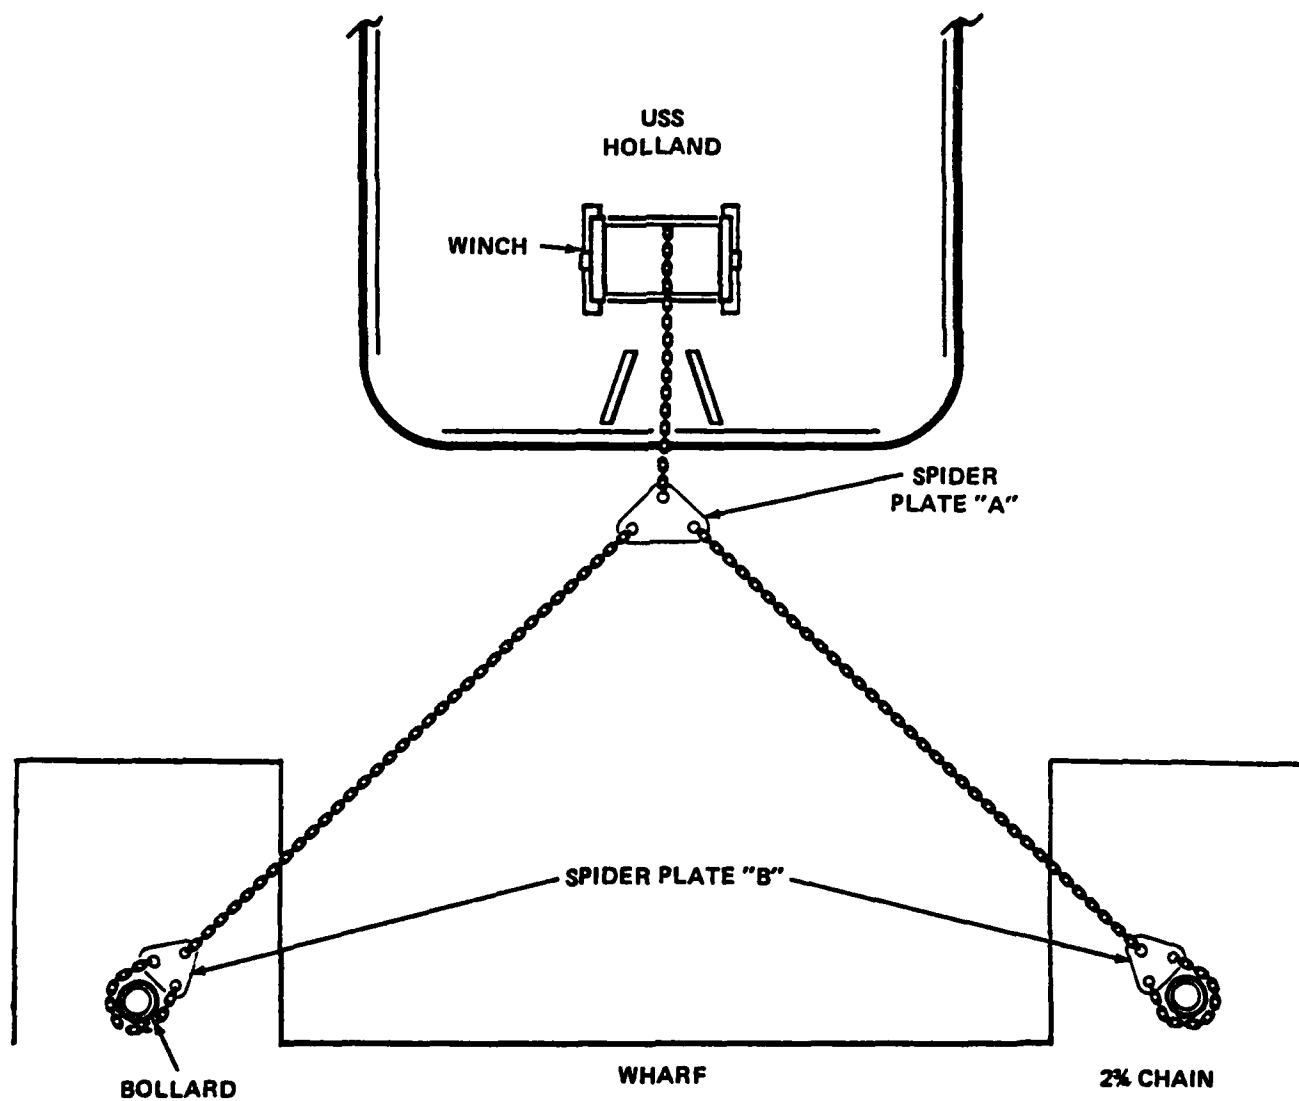
Figure A-2. USS HOLLAND (AS-32) Stern Legs

Stern Legs. The stern legs consist of 3 1/2-inch cast and Dilok chain and are connected to the southeast end of Pier C. Chain measurements were greater than 90 percent of original wire diameter but showed some surface rust. A schematic diagram of the moorings stern leg assemblies is contained in Figure A-2.

- o The visible portions of the bow legs and the stern legs are in good condition.
- o The retriever buoys are in good condition.
- o When the tender is away from the mooring, the stern legs are dropped in the water. To reduce corrosion, it is recommended that the stern legs be placed on the pier when not in use.

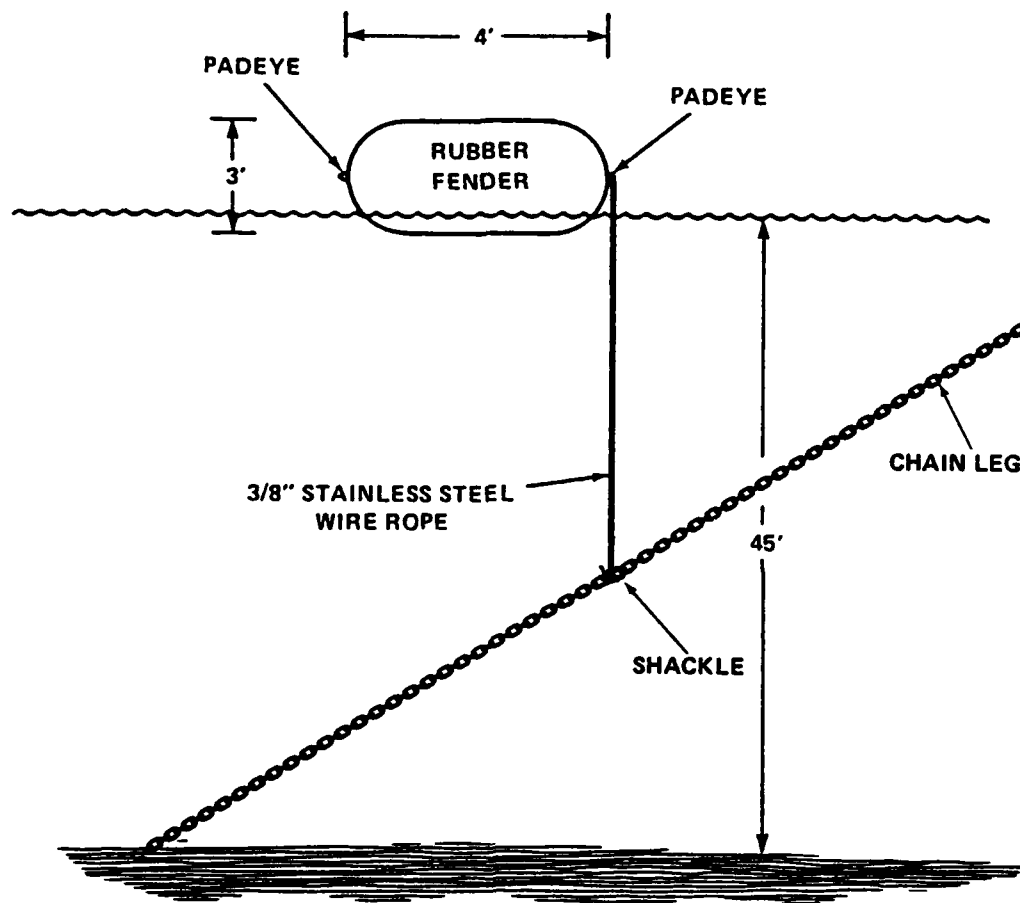
Figure A-3 Mediterranean Mooring Bow Leg Marker Buoy

Currently, large rubber fenders (normally used for protection of yard craft) are being used in place of buoys. One is located about halfway between each stakepile and the tender. (See Figure 2.) They are used as retriever buoys and navigation aids during tender mooring operations. Each marker buoy is attached by 3/8-inch steel wire rope to a shackle which is connected to the mooring chain (see Figure A-3). The fenders are in place and in good condition with moderate to light marine growth.

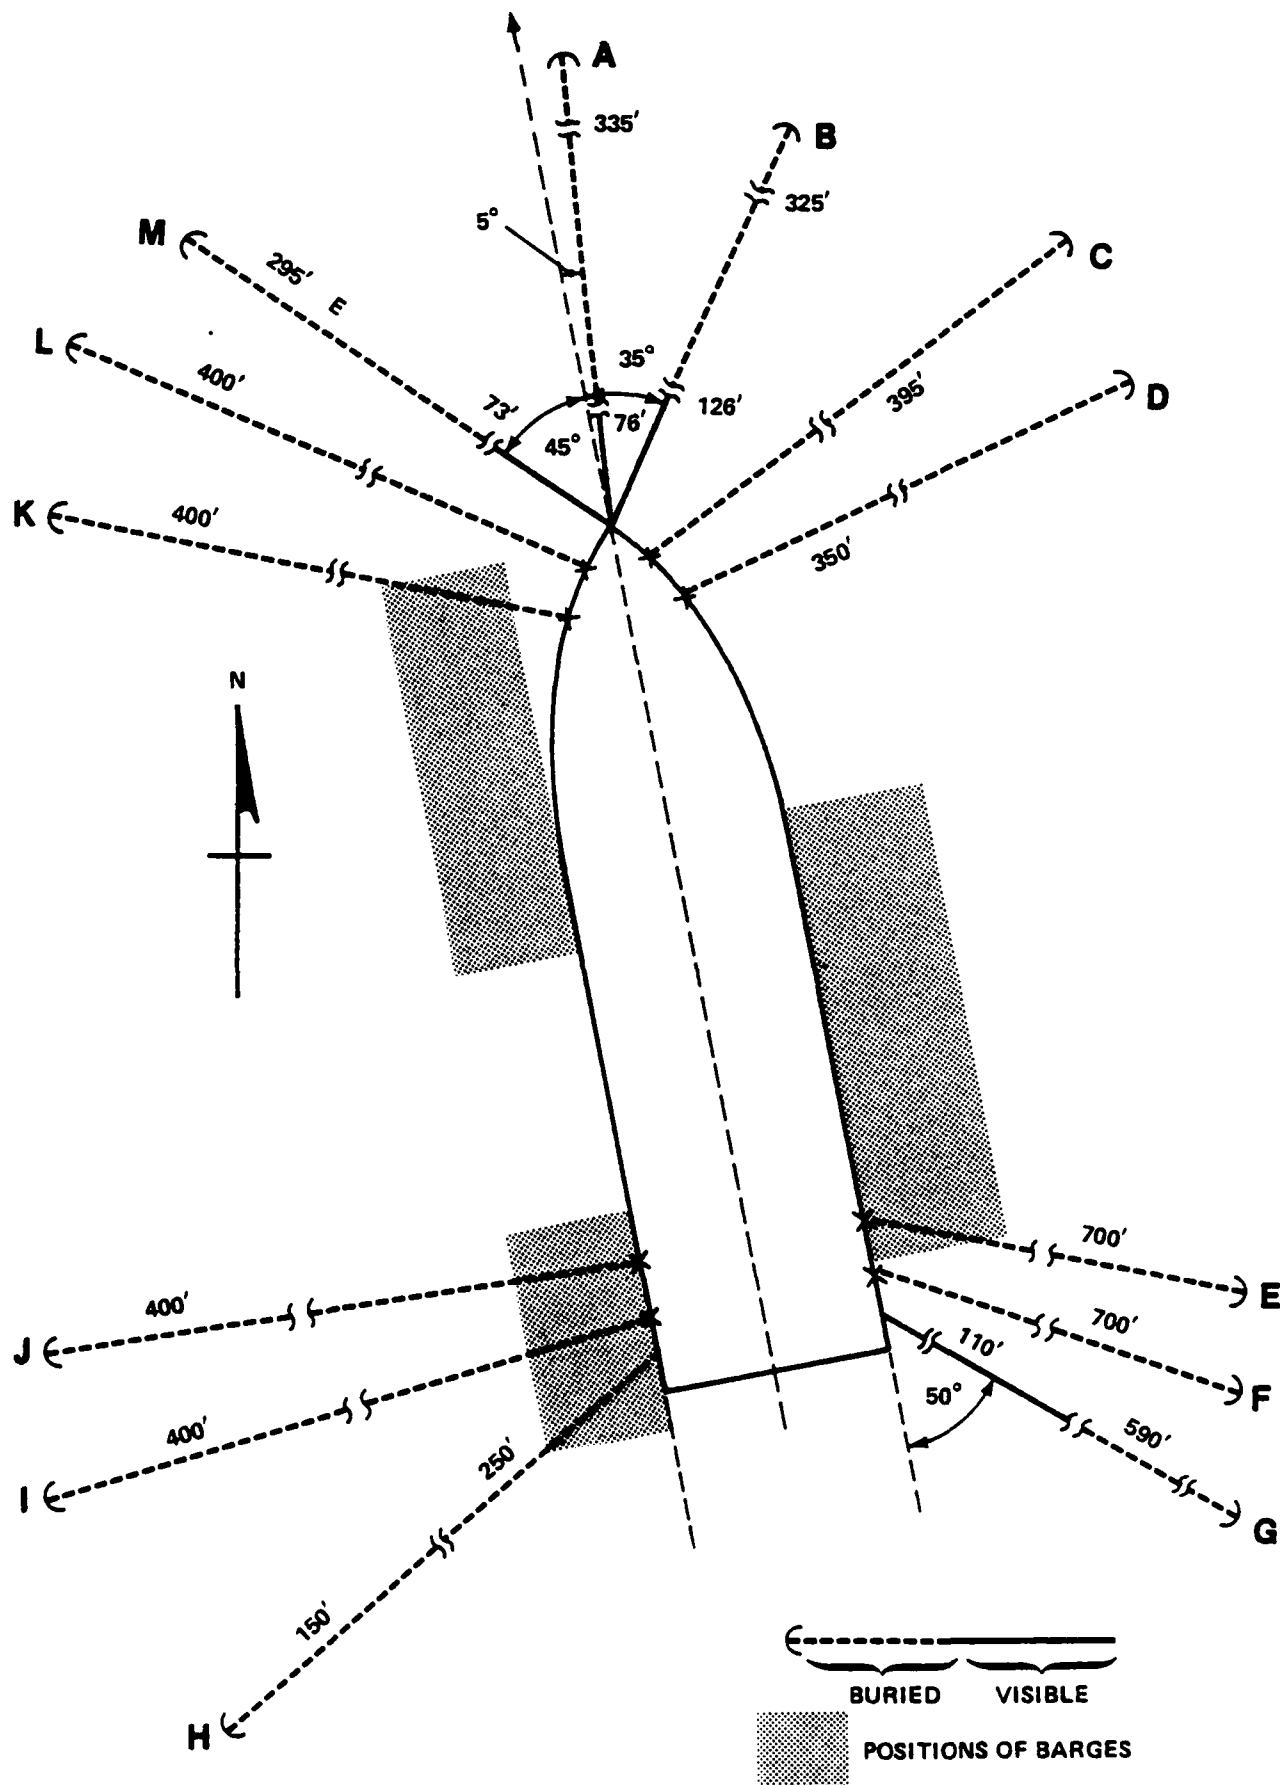
Figure A-5. ARDM LEG POSITIONS

- o Only 8 legs out of 13 were inspected due to repairs taking place on the ARDM.
- o Seven of the ARDM legs measure greater than 90 percent of original wire diameter. Leg C, however, was measured to be barely greater than 80 percent where it is attached to the hull of the ARDM. The remainder of the leg was measured to be greater than 90 percent of its original wire diameter.

- o The mooring is in satisfactory condition for continued fleet use.
- o The top two links in ground leg C should be removed during the next maintenance period.
- o In repositioning the ARDM after dredging, the chain catenaries should be checked to insure proper ARDM mooring position.
- o During this inspection, Leg C was found to have measurements near 80 percent. During the last inspection, Legs J and K (which were not inspected this time) were found to have measurements between 80 and 90 percent. Therefore, it is recommended that all three of these legs be changed out during the next scheduled maintenance period.
